**DEPARTMENT OF TRANSPORTATION**

Contract #: 04-0120F4Cty: SF/ALA Rte: 80 PM: 13.2/13.9File #: 99.28**WELDING INSPECTION REPORT****Resident Engineer:**Pursell, Gary**Address:** 333 Burma Road**City:** Oakland, CA 94607**Report No:** WIR-012361**Date Inspected:** 05-Feb-2010**Project Name:** SAS Superstructure**OSM Arrival Time:** 645**Prime Contractor:** American Bridge/Fluor Enterprises, a JV**OSM Departure Time:** 1845**Contractor:** Zhenhua Port Machinery Company, Ltd (ZPMC) Chanxing Island**Location:** Shanghai, China

**Bridge No:** 34-0006**Component:** OBG Segment 9BE**Summary of Items Observed:**

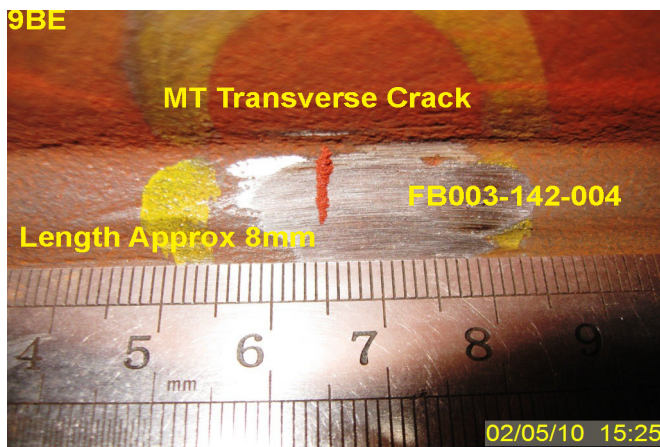
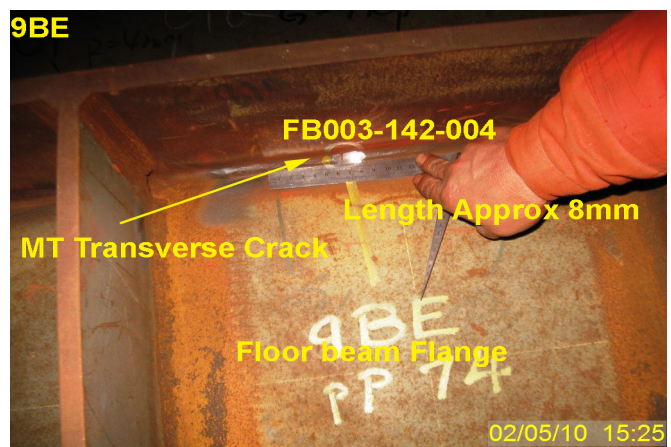
Description of Incident: During random Quality Assurance Visual review of welds located on segment 9EW, this Quality Assurance Inspector (QA) discovered one (1) Transverse linear indication measuring approximately 8mm in lengths. The indication was discovered visually and confirmed by Magnetic particle Testing (MT) by Caltrans QA. ZPMC Quality Control MT Technicians claimed that magnetic particle testing have been performed on these welds that require 25% MT. The indication is clearly marked on the material near the weld. The weld is identified as FB003-142-004 and Indication from "Y" location is 10600mm. The Panel Point number is identified as PP74 on OBG Segment 9BE. This weld is a Fillet weld joining the Floor beam Web to Flange. The Floor Beam Flange is identified as Non SPCM. For further information, please see the attached pictures
